APPLIED SCIENCE INTERNATIONAL SUCCESS STORY

A.P. MURRAH BUILDING

Oklahoma City, USA, 1995

The New Structural Vulnerability Assessment Standard

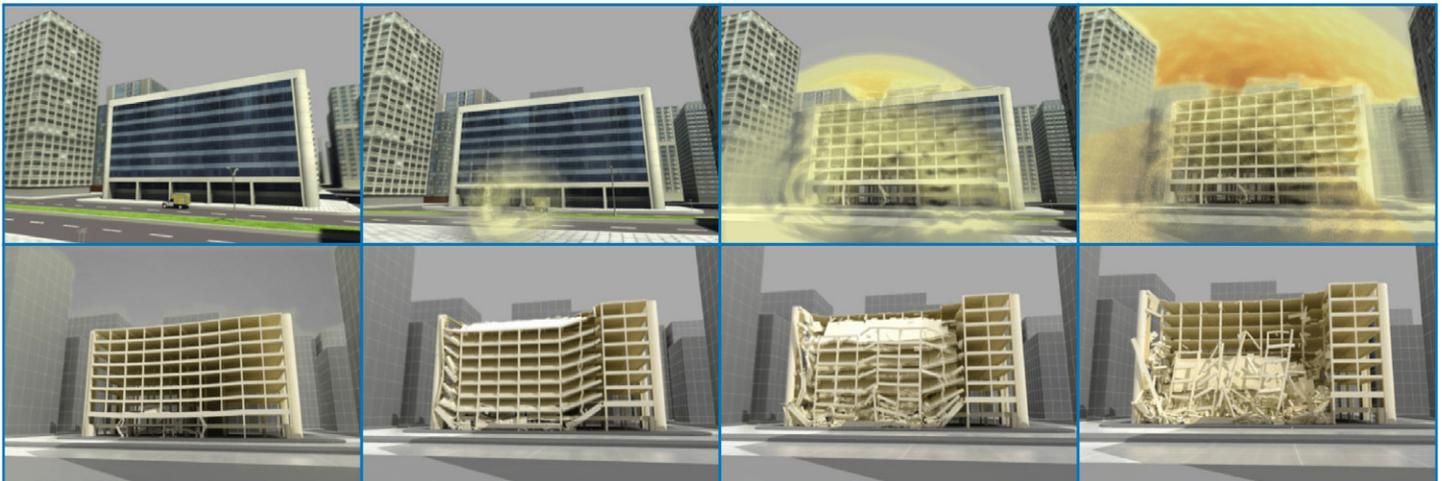
Simulation of the A.P. Murrah Building Bombing

The collapse of the Murrah Building was caused when the structure was subjected to an estimated 4000 pounds of explosives approximately 14 feet from the structure. When the bomb went off, some structural elements of the building were destroyed due to direct exposure to the pressure wave. The nearest column to the bomb location and is destroyed directly due to explosion. The transfer girder, carried by 6 columns at the building front has the collapses due to curtailment of reinforcement bars and the re-distribution of bending moments in the transfer girder. After collapse of the transfer girder, excessive loads at the girders on the 4th to the 9th floor levels caused a disproportionate collapse of a significant portion of the structure.

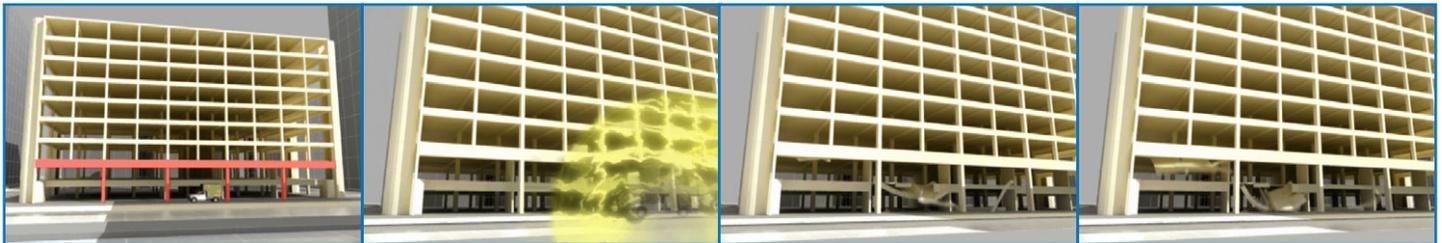
Scenario 2: Girder Strengthened

Engineers tend to use curtailment of reinforcement bars to reduce the weight of steel used in a structure, hence reducing construction cost. In reviewing the original reinforcement detailing of the transfer girder, it is obvious that the top reinforcement ratio was reduced at the mid-spans while the bottom reinforcement is curtailed at column locations. Designers of such buildings at the time did not consider failure of one or more supporting elements which will cause dramatic changes of internal forces and bending moments.

In the real collapse case, the failure of column G20 cause the span of transfer girder to be doubled, hence the bending moment increased to 4 times. Adding the dynamic loads as a result of the direct pressure wave cause the bending moment value to be significantly increased. In addition, the bending moments of the transfer girder at column G20 changed its direction to a negative moment while the reinforcement is curtailed at the failed column location.

In this case, to show how significant the reinforcement detailing of the transfer girder would be in preventing a disproportionate collapse of the structure, the reinforcement bars are assumed continuous at the transfer girder with 7 square inches at both the top and bottom of the girder. The assumed reinforcement area is almost double the actual design. Although the bending moment due to failure of the transfer girder will increase to more than 4 times the design values. Analysis results shown above show that improving reinforcement detailing of the transfer girder resulted in the localization of the failure to column G20 and some parts of the slabs due to direct pressure wave.

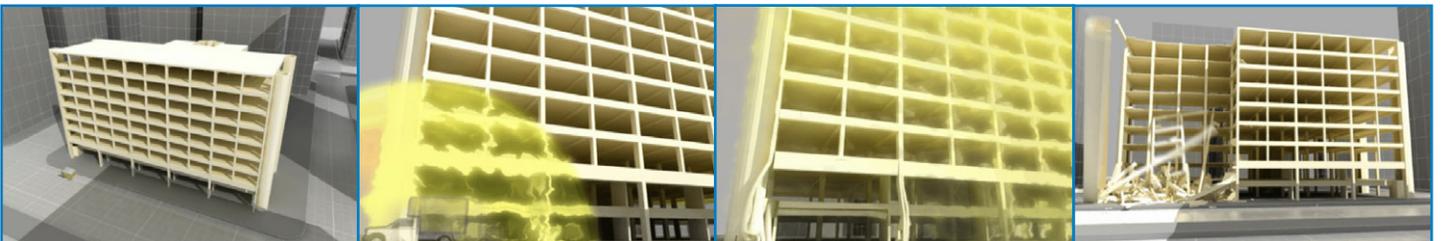
Scenario 3: Blast moved 60ft to building corner.

In this scenario, the bomb blast is moved from its original location 60 feet towards the building corner. As shown below, the direct pressure wave cause failure of column G20 and parts of floor slabs due to uplift pressure. Then the girders supported by G28 in upper the upper floors collapses in shear as. This case shows that the collapse propagated in vertical direction only.

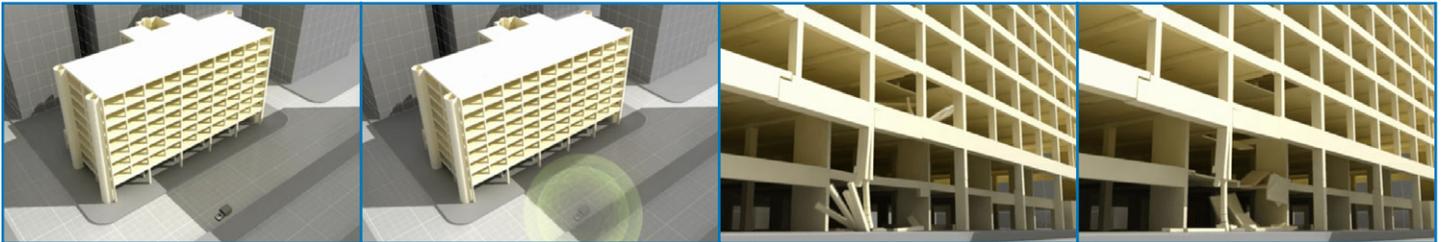
Scenario 4: Blast moved 20ft away from building.

In this case we assume that the truck could not stop in front of the building, due to existence of a barrier for example. The bomb blast is placed 20 feet away from its original location as shown below. The direct pressure wave caused high uplift pressure on the slabs of first floor. However, collapse is limited to floor slabs facing the high uplift pressure and progressive collapse did not occur. This sample shows the importance of having barriers that establish safe standoff distances around critical structures to keep enough distance between vehicles carrying dangerous payloads.

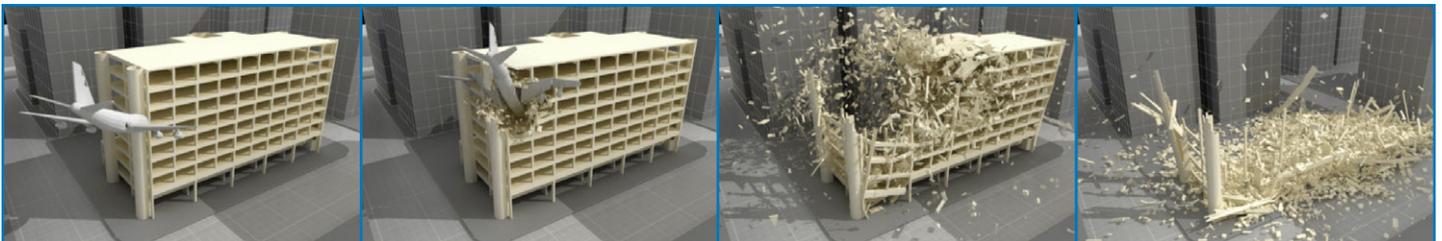
Scenario 5: Plane crashes into building.

The threat of objects colliding with and damaging structures, whether intentionally or accidentally is of genuine concern. Vehicular collisions with buildings or bridges occur mainly in urban areas and are due to single vehicles unintentionally leaving the roadway. In this final case, an aircraft impact is analyzed as a potential threat. Important facilities must take into consideration aircraft collisions, especially if these structures lie within 10 kilometers (6 miles) of an airport. The resulting damage can be catastrophic, as is the case here. Additionally, impacts of barges or flood debris with bridges or bridge supports are also not uncommon events.
